**Absolute  
Civil  
Engineering  
Solutions LLC**

**FIFTY-YEAR BUILDING SAFETY INSPECTION**

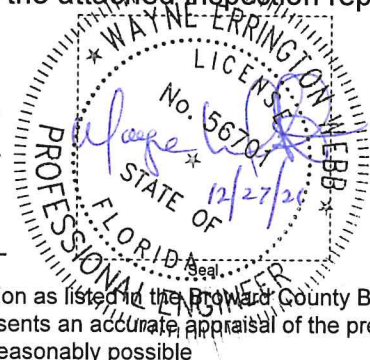
This report has been based upon the minimum inspection guidelines for building safety inspection as listed in the Broward County Board of Rules and Appeals' Policy #05-05. To the best of my knowledge and ability, this report represents an accurate appraisal of the present condition of the structure, based upon careful evaluation of observed conditions, to the extent reasonably possible

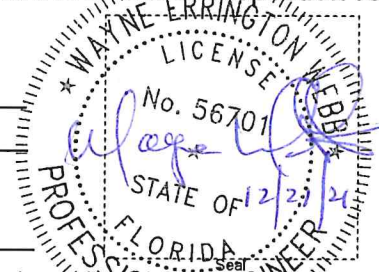
This report has been based upon the minimum inspection guidelines for building safety inspection as listed in the Broward County Board of Rules and Appeals' Policy #05-05. To the best of my knowledge and ability, this report represents an accurate appraisal of the present condition of the electrical system, based upon careful evaluation of observed conditions, to the extent reasonably possible

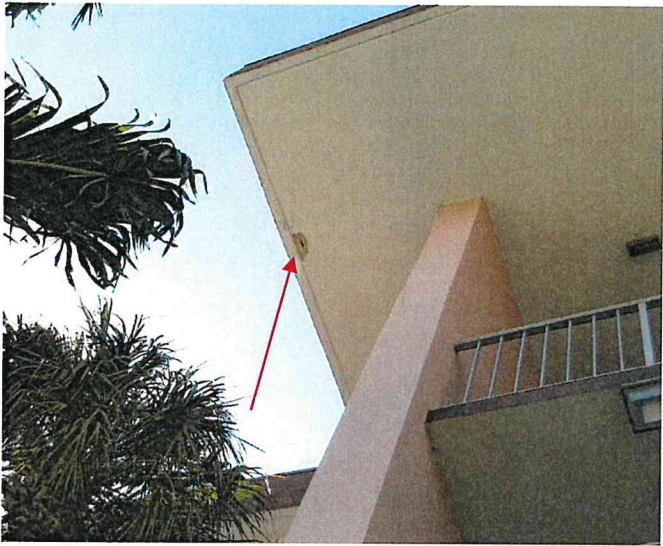
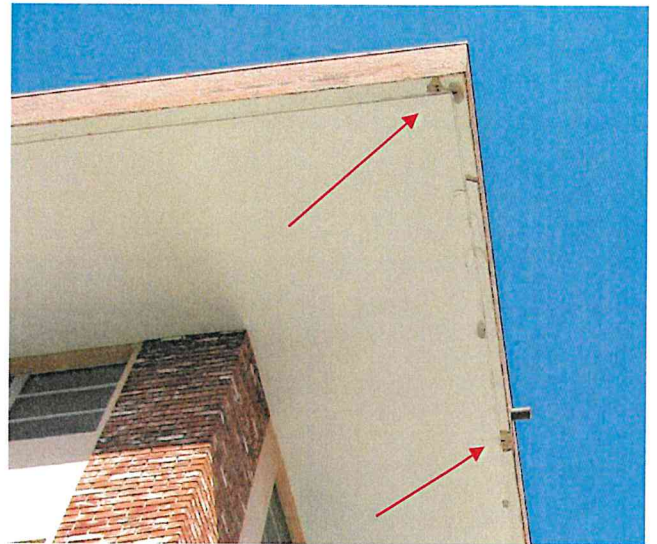
1. View of spalled concrete with exposed rebar in 4<sup>th</sup> floor roof slab. Please repair.

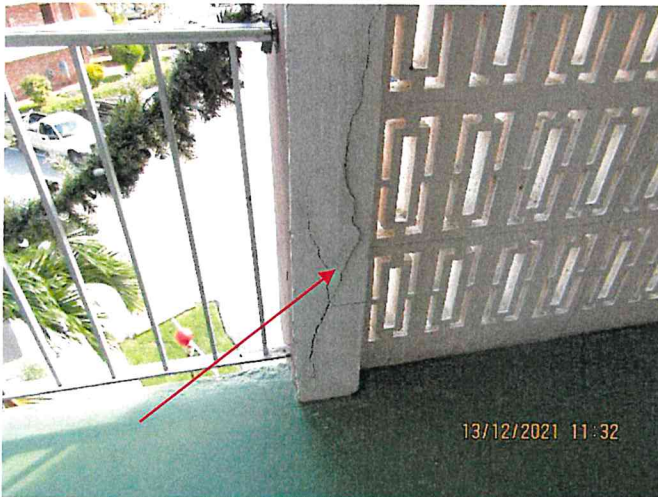
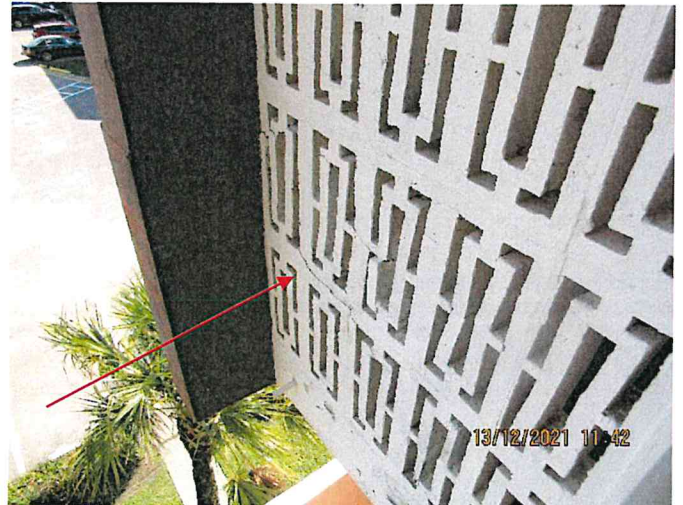
2. View of cracked concrete columns and decorative concrete bricks at 4<sup>th</sup> floor balconies. Please repair.

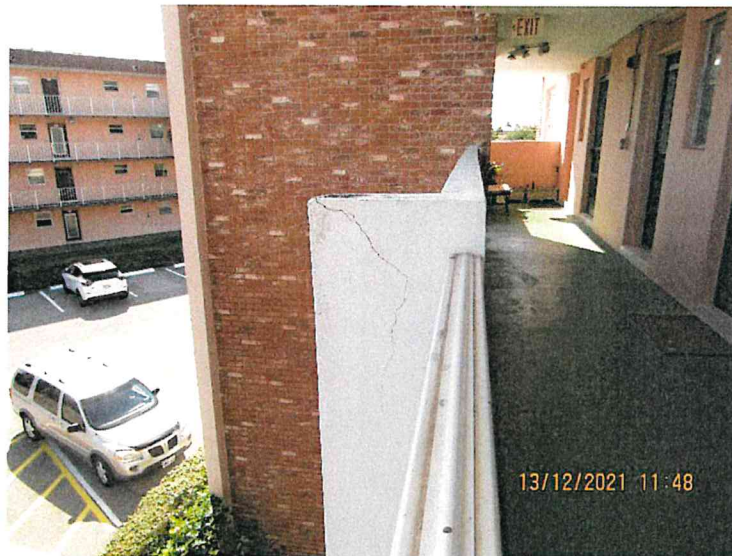
3. View of crack in concrete wall of 3<sup>rd</sup> floor balcony. Please repair

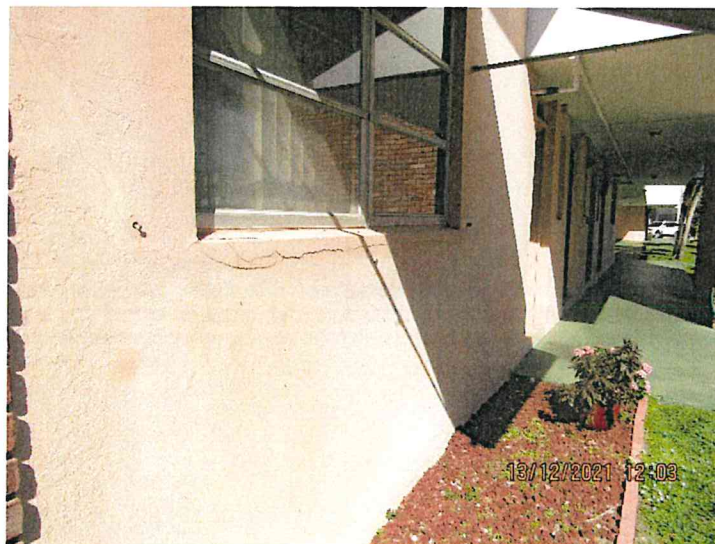
4. View of crack in concrete wall below window sill. Please repair.

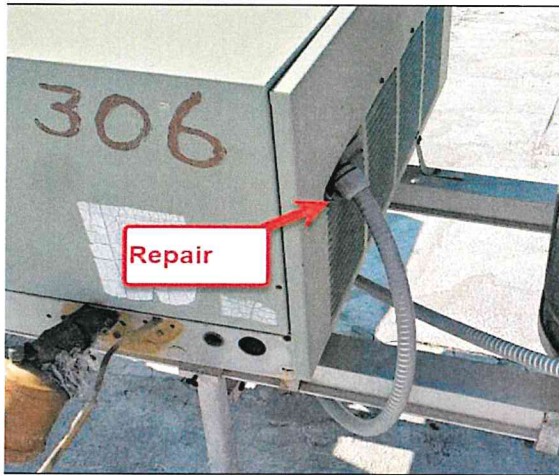
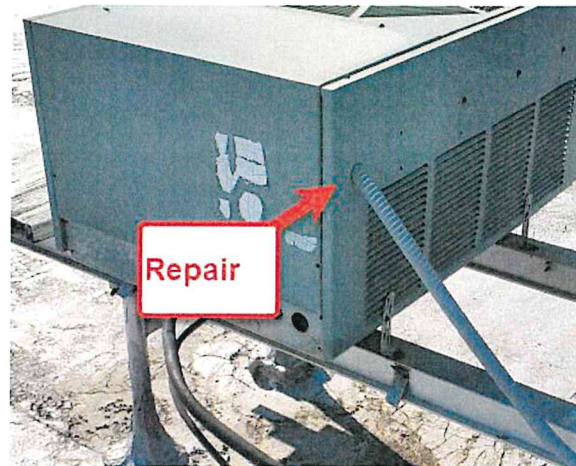
5. View of electrical connections at AC Rooftop Condenser Units. Please repair.

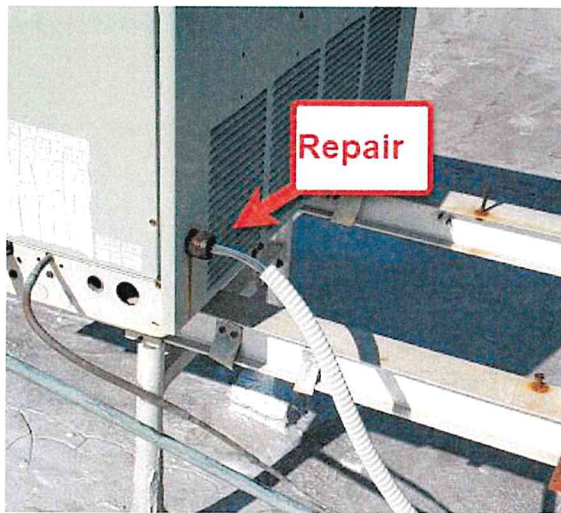
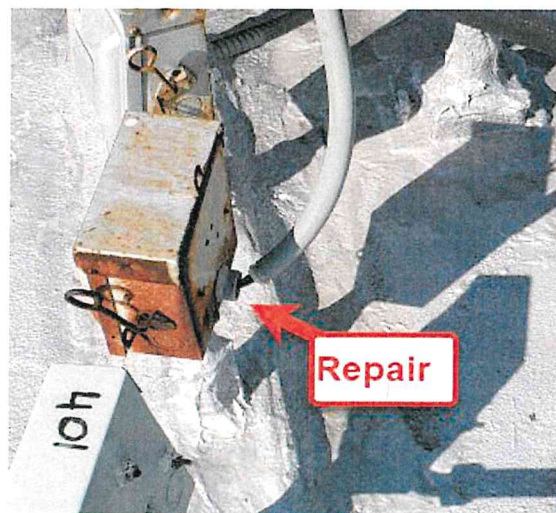
6. View of electrical wiring for AC units and AC disconnects on the rooftop. Please repair
